DURABILITY INVESTIGATION OF A ONE-QUARTER-SECTOR  
COMBUSTOR AT HIGH VALUES OF INLET-AIR  
PRESSURE AND TEMPERATURE

By Jerrold D. Wear

Lewis Research Center  
Cleveland, Ohio

June 1960

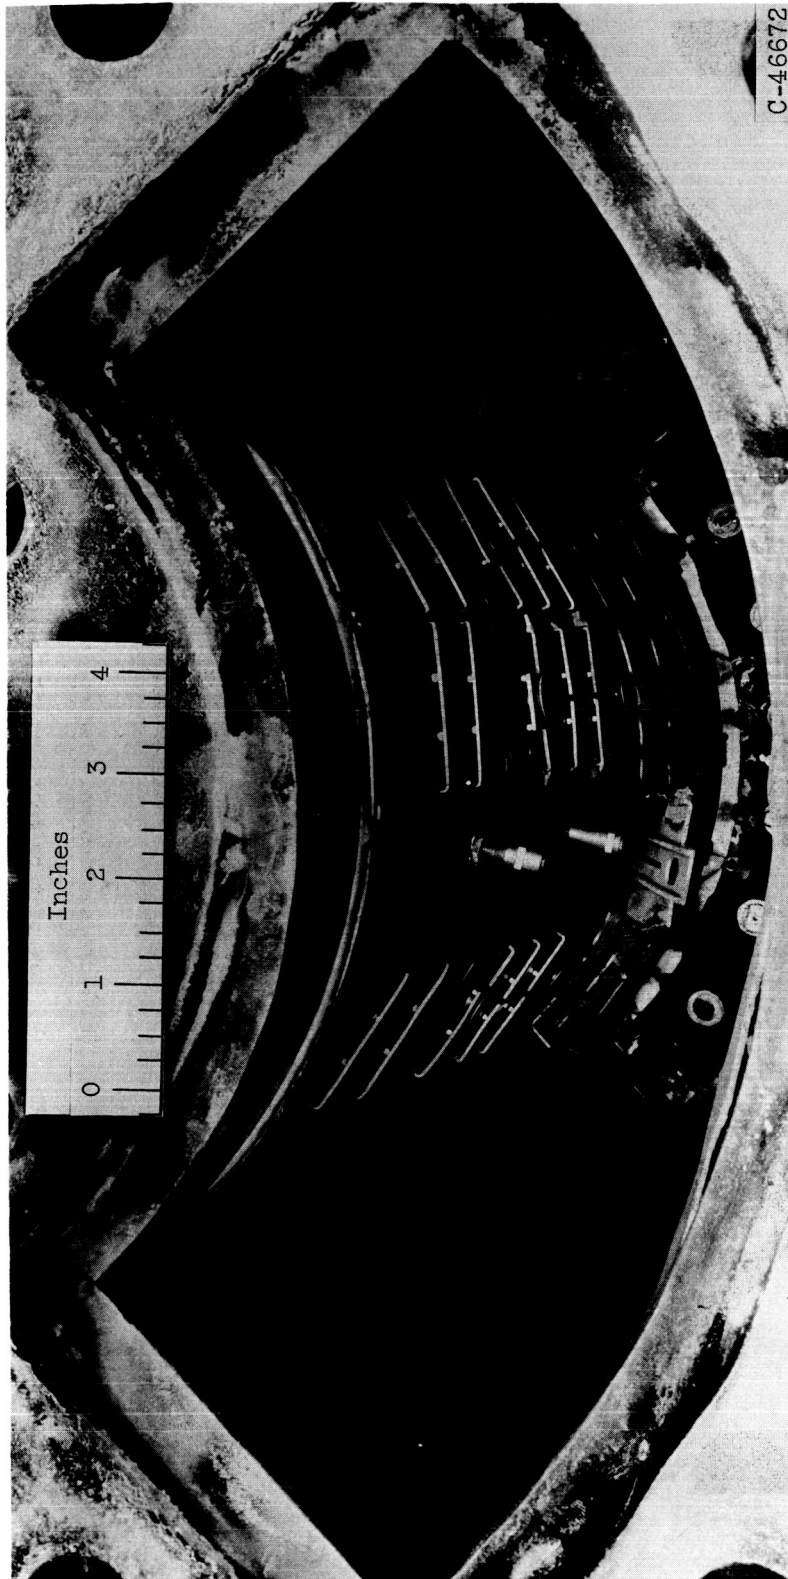
(a) Short-radius channels.

A temperature-pressure survey was started, and about halfway through the second radius (fig. 7) the gas temperature increased sharply to above 3100° F and the thermocouple failed. The test was stopped, and inspection showed one zone-C channel (fig. 3) hanging down into the combustion area and a zone-D channel gone altogether. Both were from the short-radius side or inner wall. Photographs taken of the liner (fig. 8) show that the tabs had come off two of the support bolts. The failed tabs, which had been welded to the bolts, looked as if the metal had torn away from around the weld instead of the weld failing. The other channels seemed in good condition. Some of the welds holding the pilot-section steps had broken, and the steps were warped. The amount of coke on the nozzle plate was smaller than at the beginning of the test.

Figure 8. - Failure of tabs from support bolts in second and third rows. Total run time, 9.7 hours.

Since other tabs (0.031-inch-thick Inconel metal) showed some warping, all were removed from the support bolts and replaced with tabs made from 0.043-inch-thick Inconel metal.

Two new channels were installed, the welds were repaired on the pilot section, and most of the coke was removed.

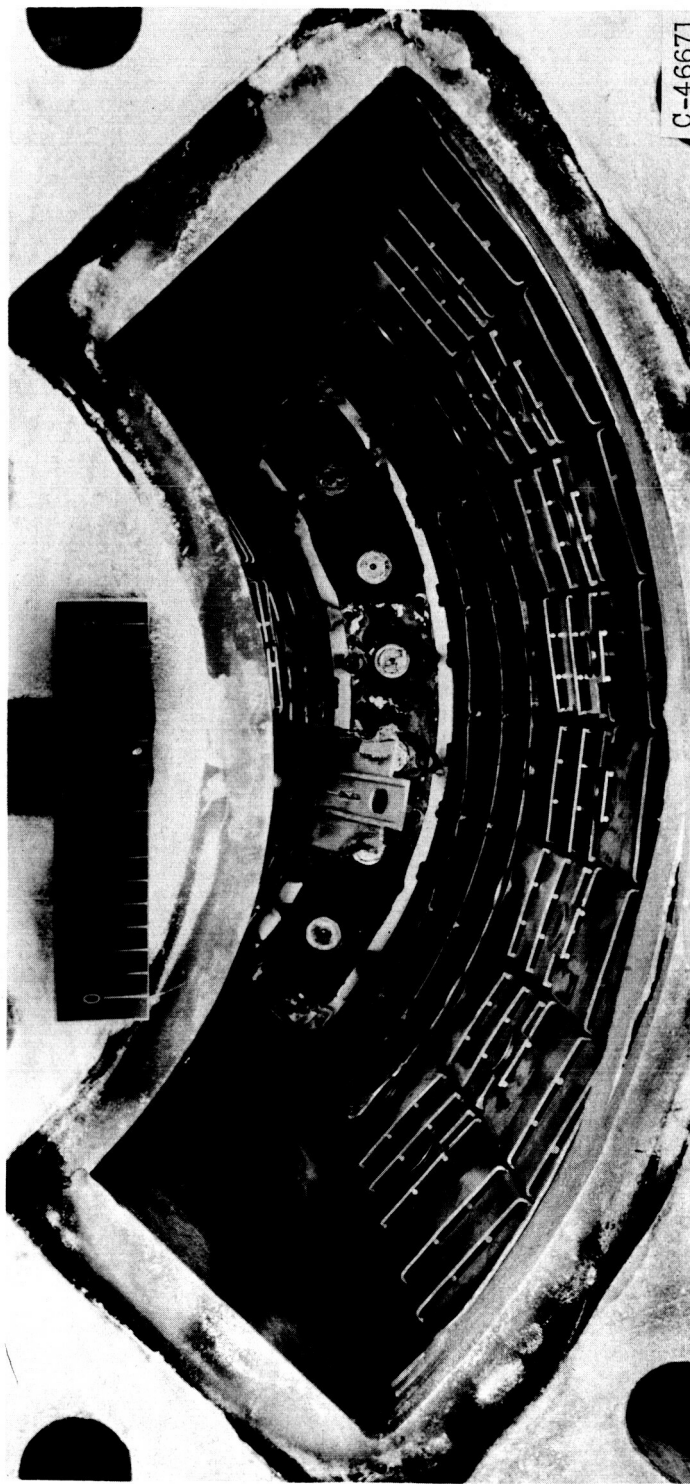
(b) Pilot section and long-radius channels.

Figure 8. - Concluded. Failure of tabs from support bolts in second and third rows. Total run time, 9.7 hours.

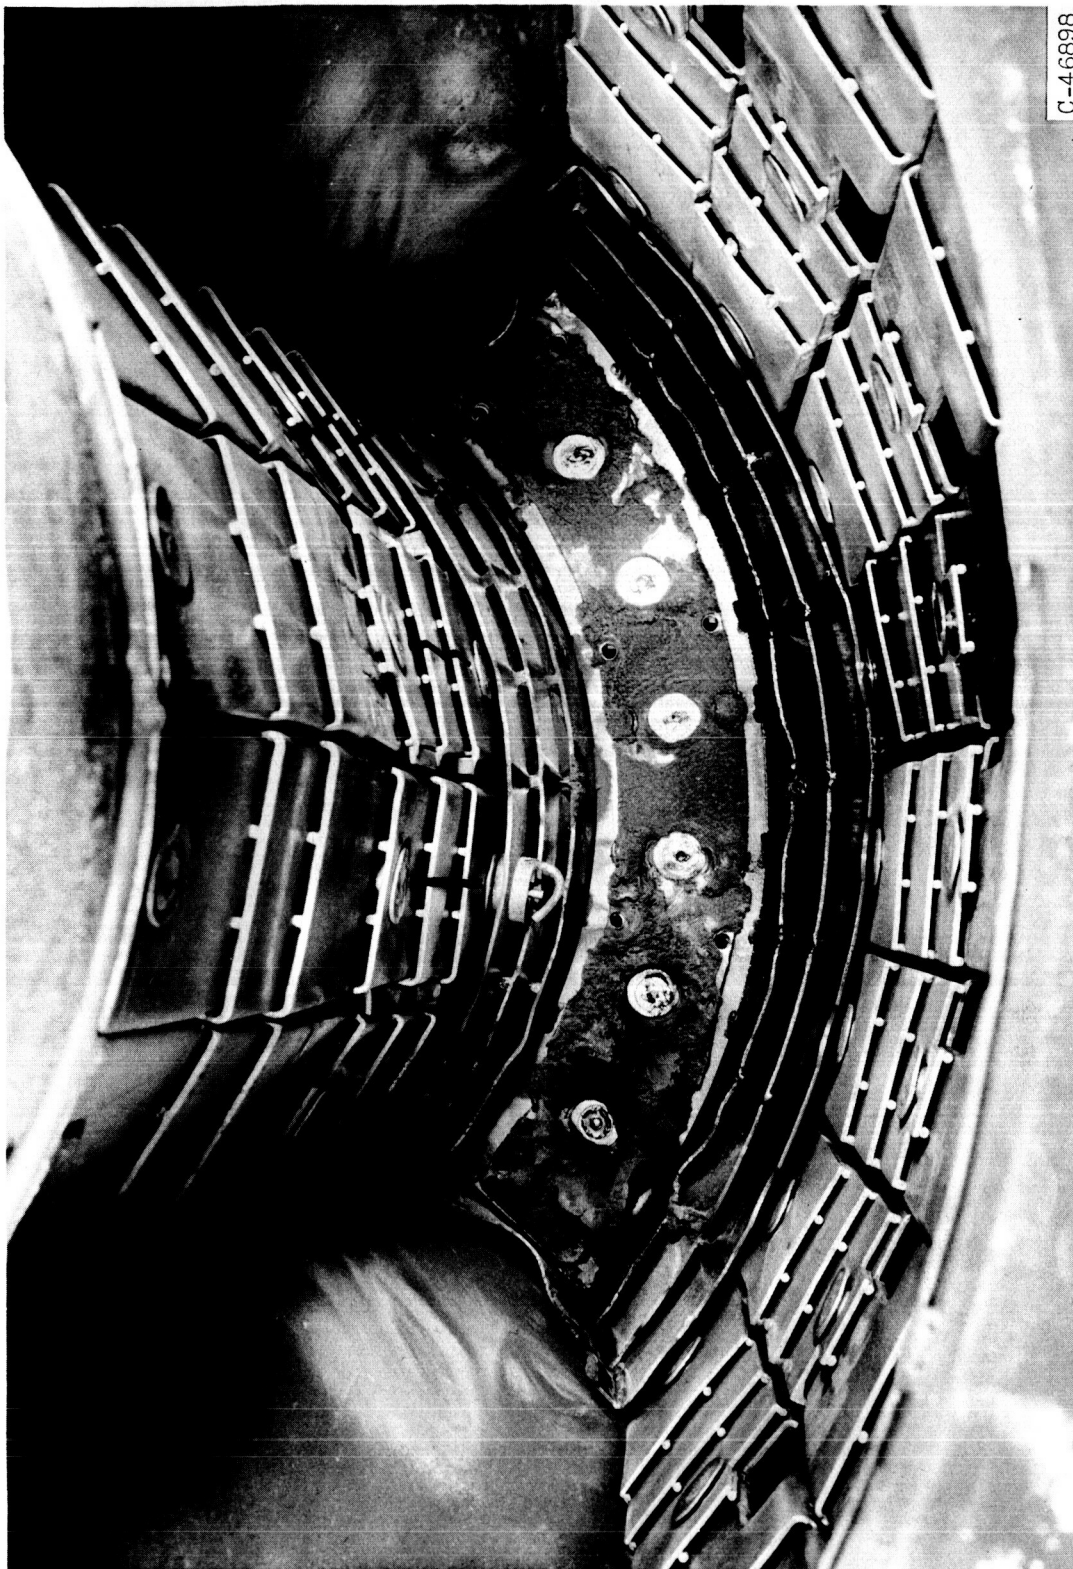
(a) Short-radius channels, pilot section, and coke deposits.

A photograph (fig. 9) was taken of the liner after operation at condition F. There were no warped channels or broken tabs, although some welds on the side of one channel (center of long radius, zone C) had broken. There was considerable warping of some of the pilot-section steps, and the sides were warped inwards more than before. Comparison of figure 9 with figures 5 and 8 show more space between pilot section and channels at both the short- and long-radius sides. There was a large amount of coke on the nozzle plate around the nozzle on the left side.

Figure 9. - Warped steps of pilot section, excess clearance between pilot section and channels, and coke deposits. Total run time, 20.7 hours.

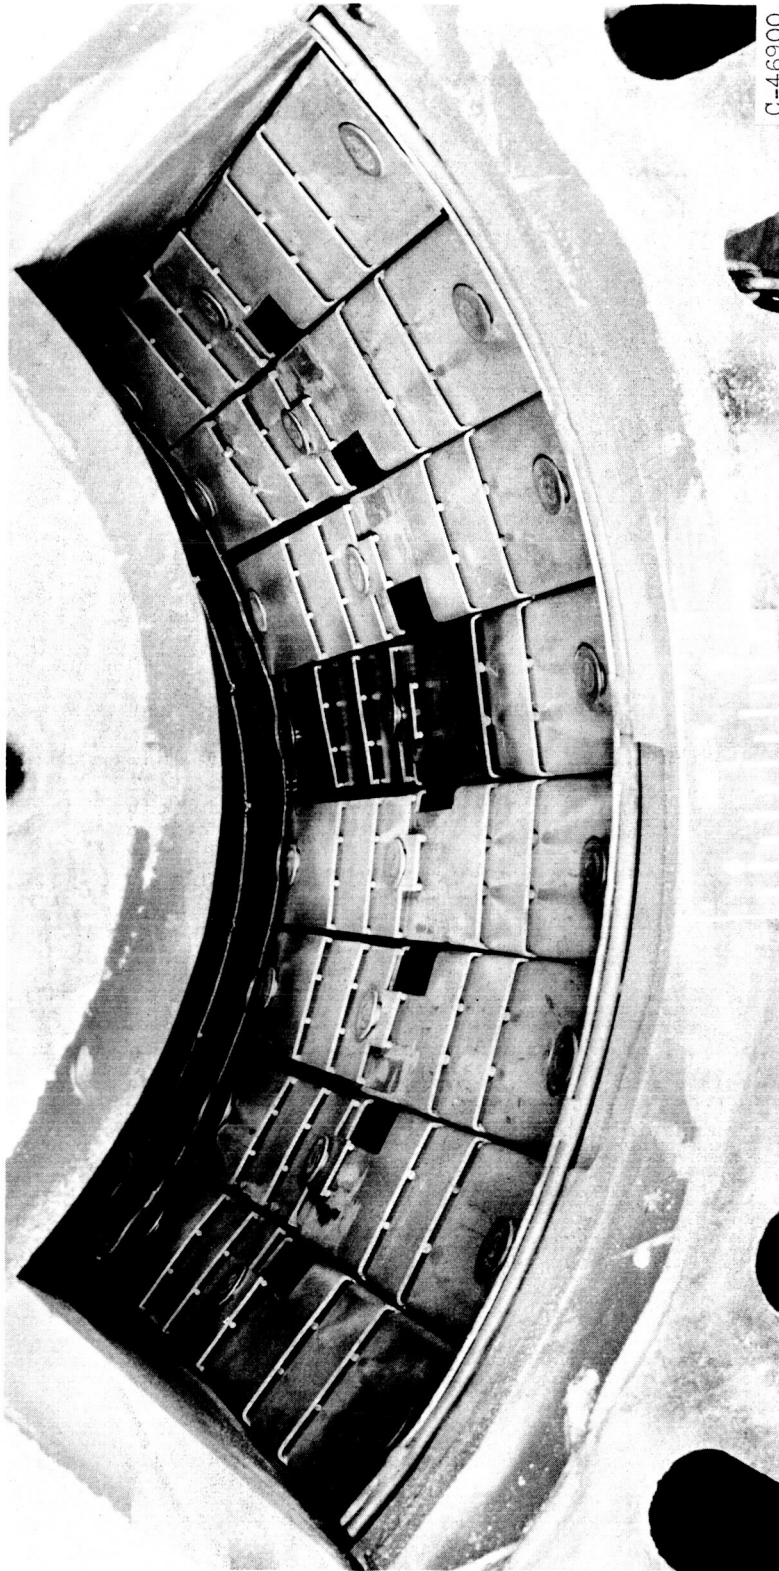
(b) Long-radius channels.

Figure 9. - Concluded. Warped steps of pilot section, excess clearance between pilot section and channels, and coke deposits. Total run time, 20.7 hours.

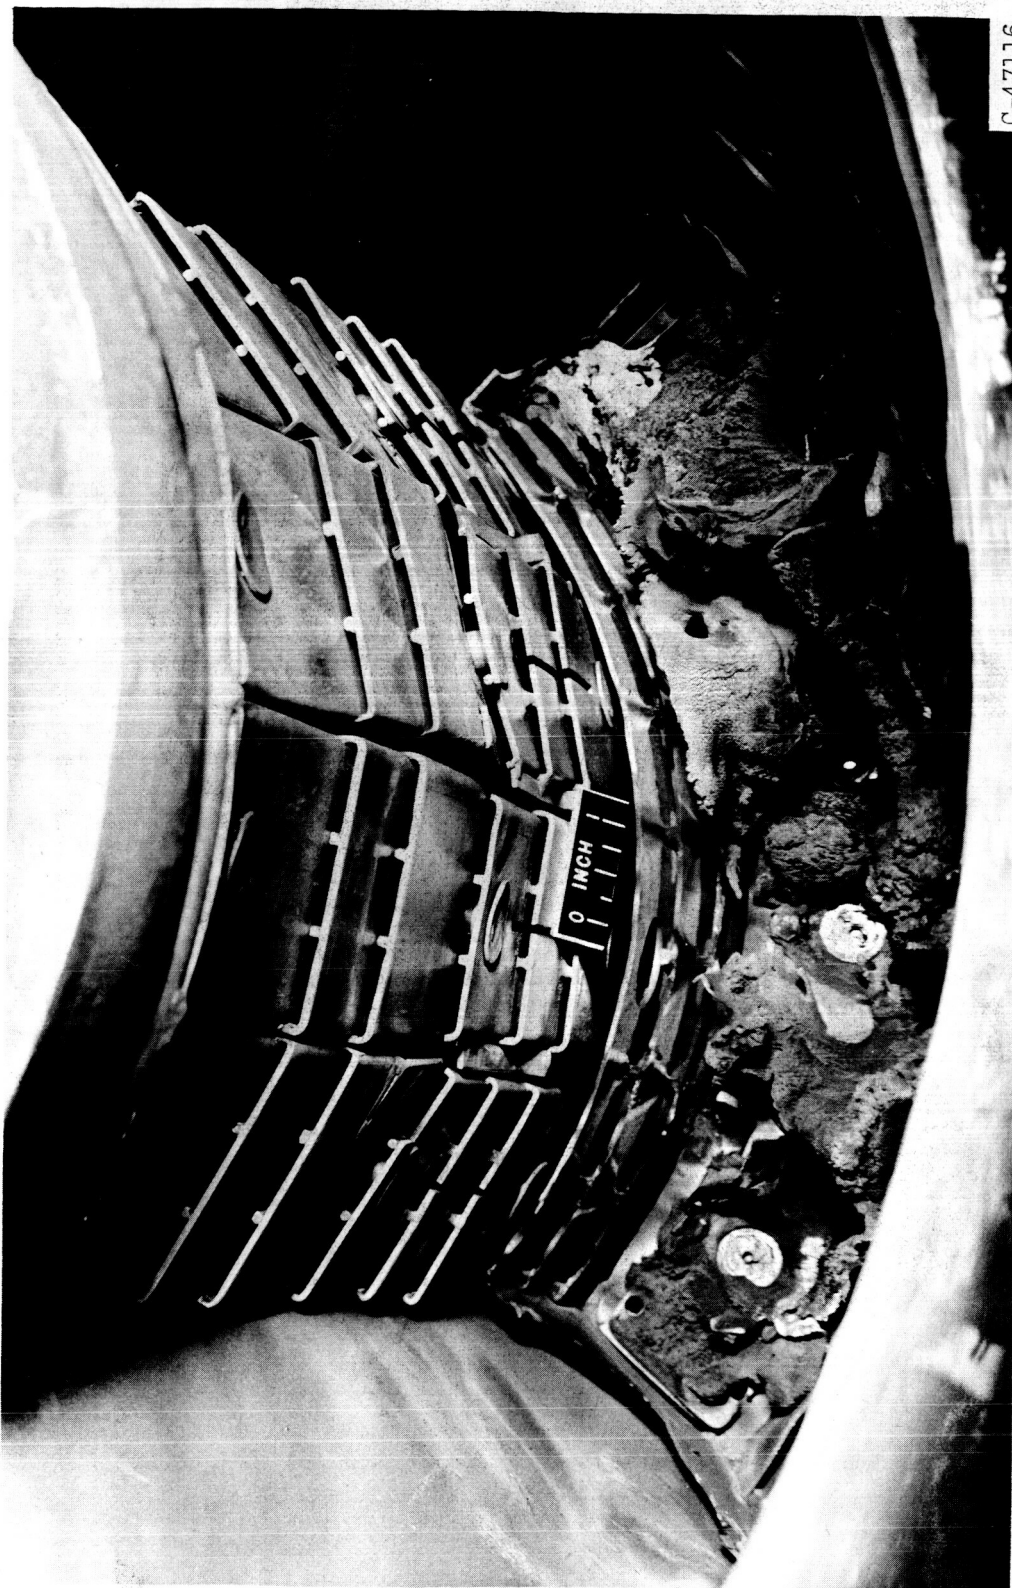
(a) Short-radius channels and pilot section.

A photograph (fig. 10) was taken of the liner after operation at condition H. The coke formation was heavier than it had been for any of the previous conditions. It had bridged over several of the nozzles. The burned hole in the nozzle plate had enlarged enough to reach the nozzle hole. The pilot section had a weld broken on one of the steps. A zone-D channel, short radius second from right, had bent or sagged a small amount. The failure had taken place on a flat part of the channel at the end of the bent-over side pieces (the channel cross section changes from a U-shape to flat). The channel was straightened, the pilot-section step was rewelded, and the coke was cleaned out. A new nozzle protector plate was installed.

Figure 10. - Warped short-radius channel and coke deposits in pilot section. Total run time, 30.4 hours.

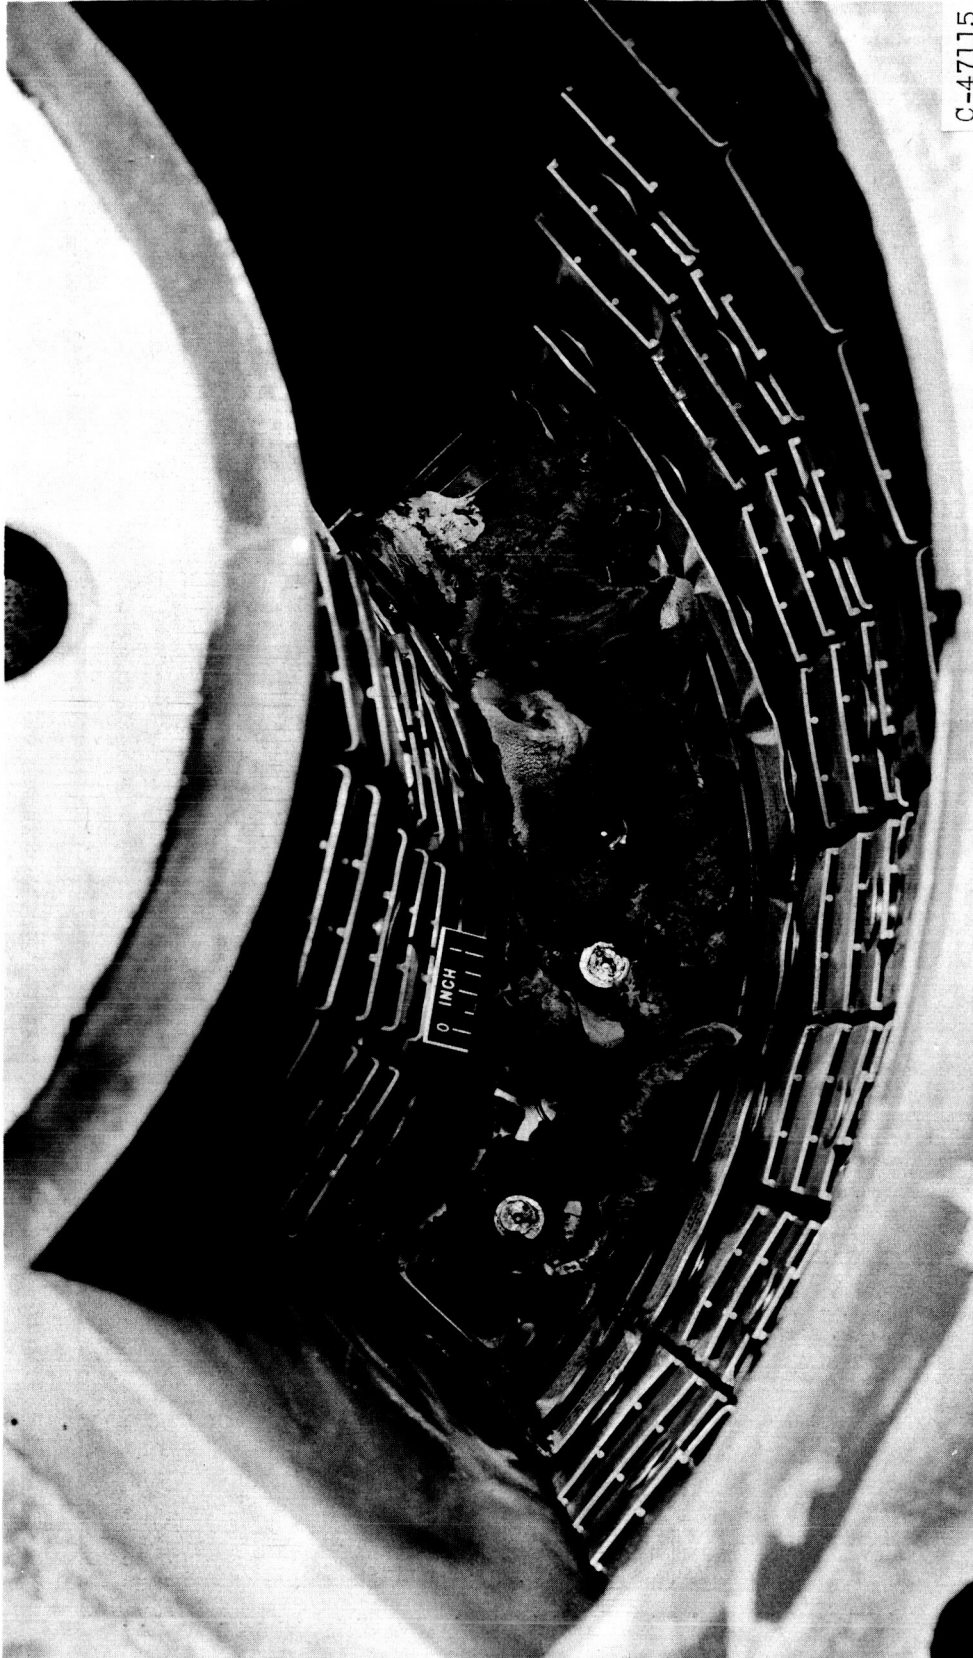
(b) Long-radius channels and pilot section.

Figure 10. - Concluded. Warped short-radius channel and coke deposits in pilot section. Total run time, 30.4 hours.

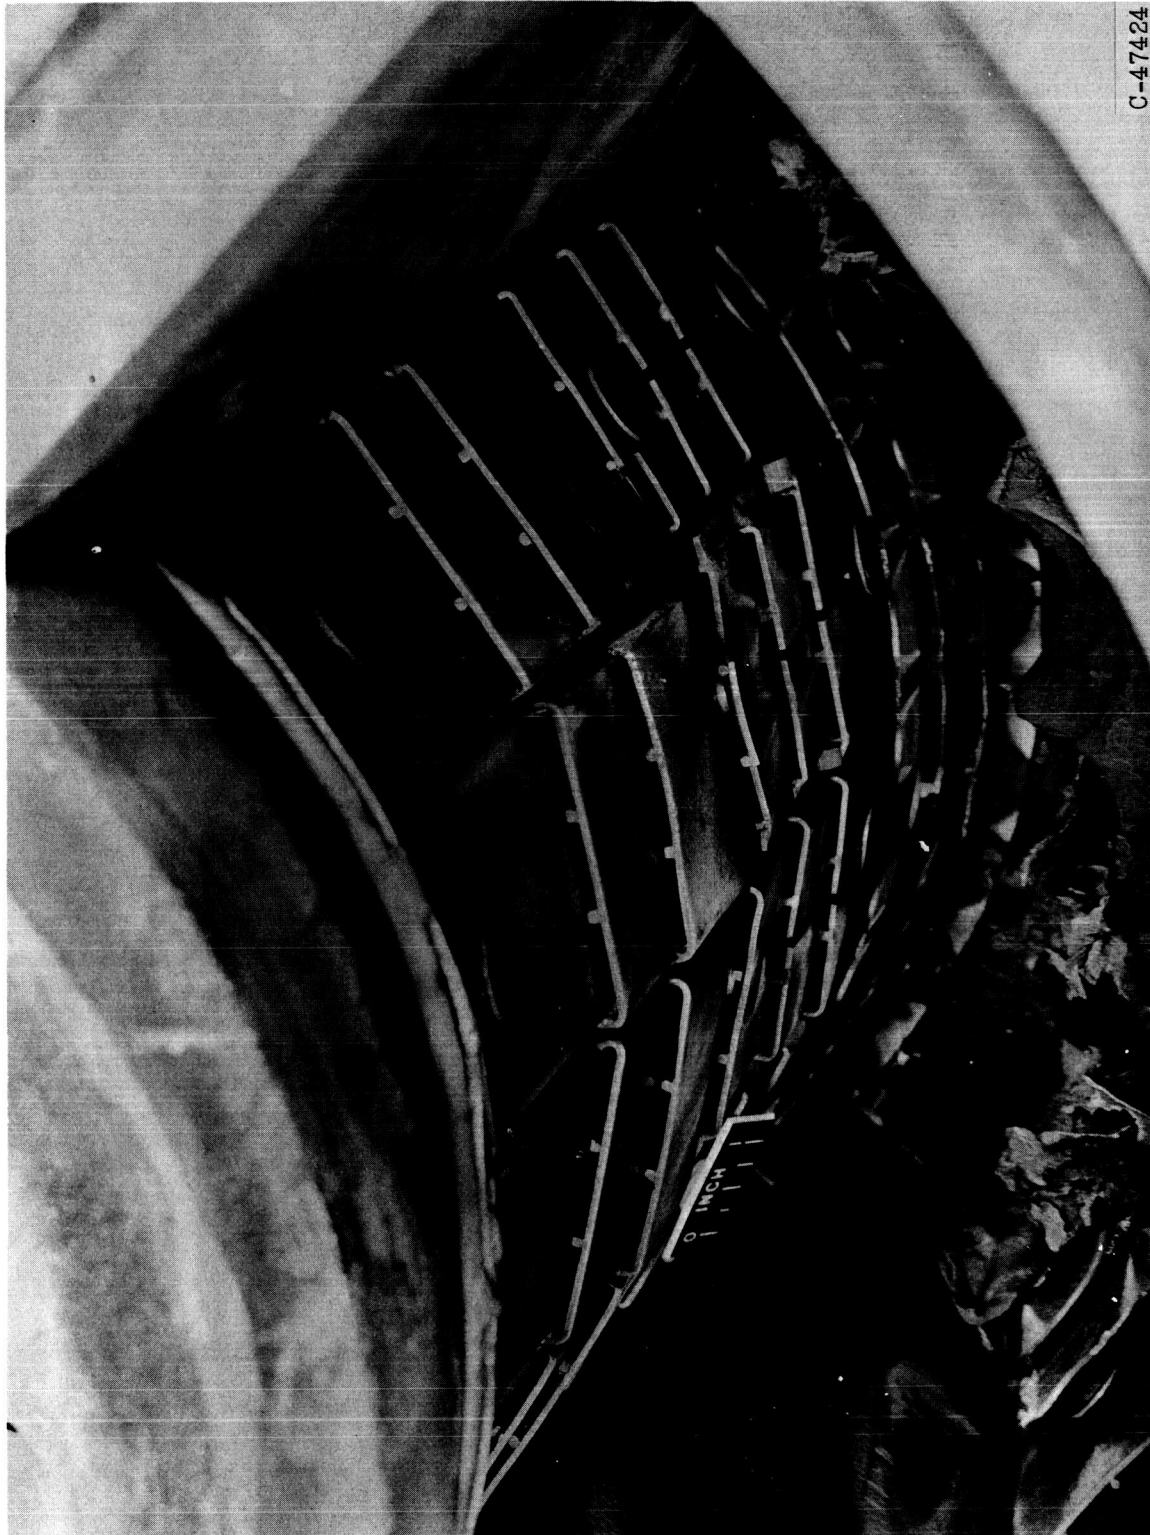
(a) Short-radius channels and coke deposits.

A photograph of the liner is shown in figure 11. There was a large amount of coke on the nozzle plate; some of it extended downstream nearly to the end of the pilot section. A sagging or bend in a zone-D channel, short radius, can be seen. This failure occurred, as before, on a flat section of the channel. The middle two channels were bent more than the outer two. It can also be seen that some of the tabs were bent a considerable amount. The channels on the long-radius side appeared generally to be in good condition. Some of the channels in zone C had steps that were raised or warped somewhat. The space between the pilot section and channels had increased from the original spacing. Two of the steps in the pilot section were warped.

Figure 11. - Warped short-radius channels and coke deposits in pilot section. Total run time, 38.2 hours.

All the channels on the short-radius side were straightened, and the one that had bent or warped the most was replaced with a new one. The pilot-section steps were straightened, and the spacing with the channels was adjusted to the original spacing. All the coke was cleaned out of the pilot section.

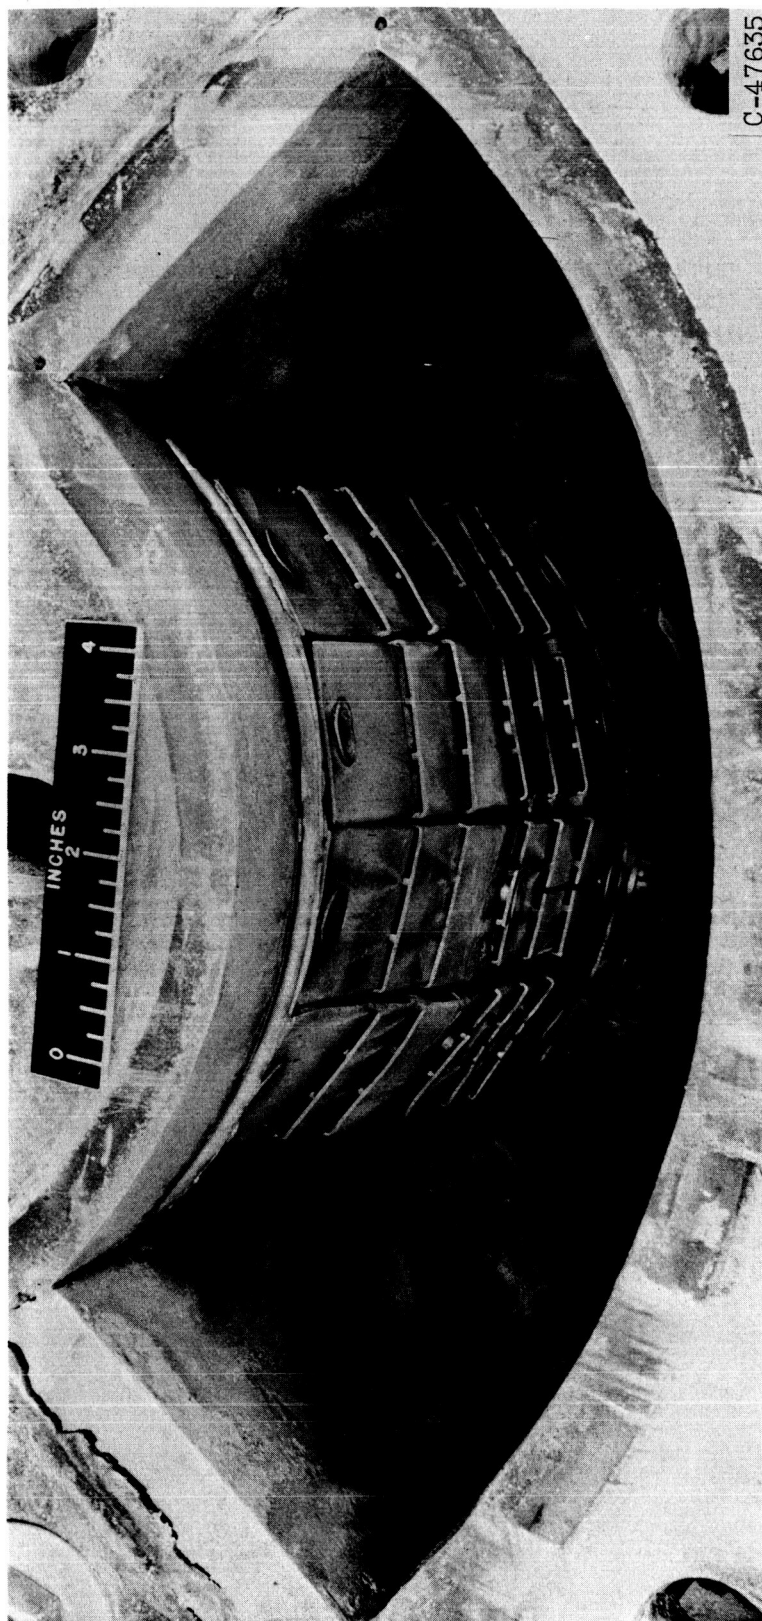
(a) Short-radius channels.

A photograph of the liner is shown in figure 12. There were no broken tabs or channels. However, all four short-radius channels (zone D) were bent or sagged down. The coke deposits completely filled the back of the pilot section and were bridged over all the nozzles. One

Figure 12. - Warped short-radius channels, coke deposits, and warped pilot-section steps. Run time, 41.2 hours.

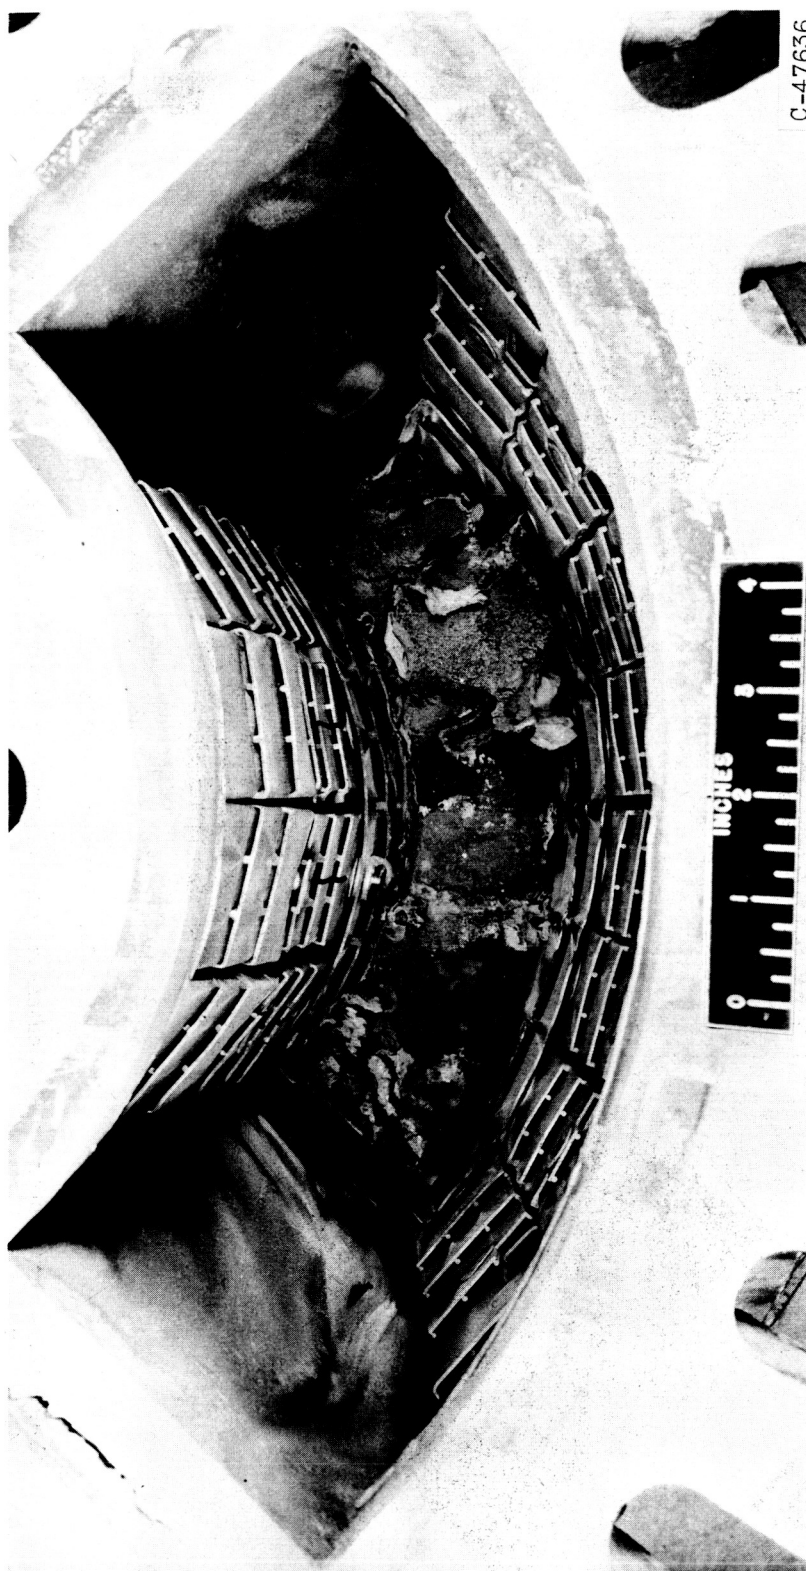
(b) Pilot-section coke deposits.

Figure 12. - Continued. Warped short-radius channels, coke deposits, and warped pilot-section steps.  
Run time, 41.2 hours.

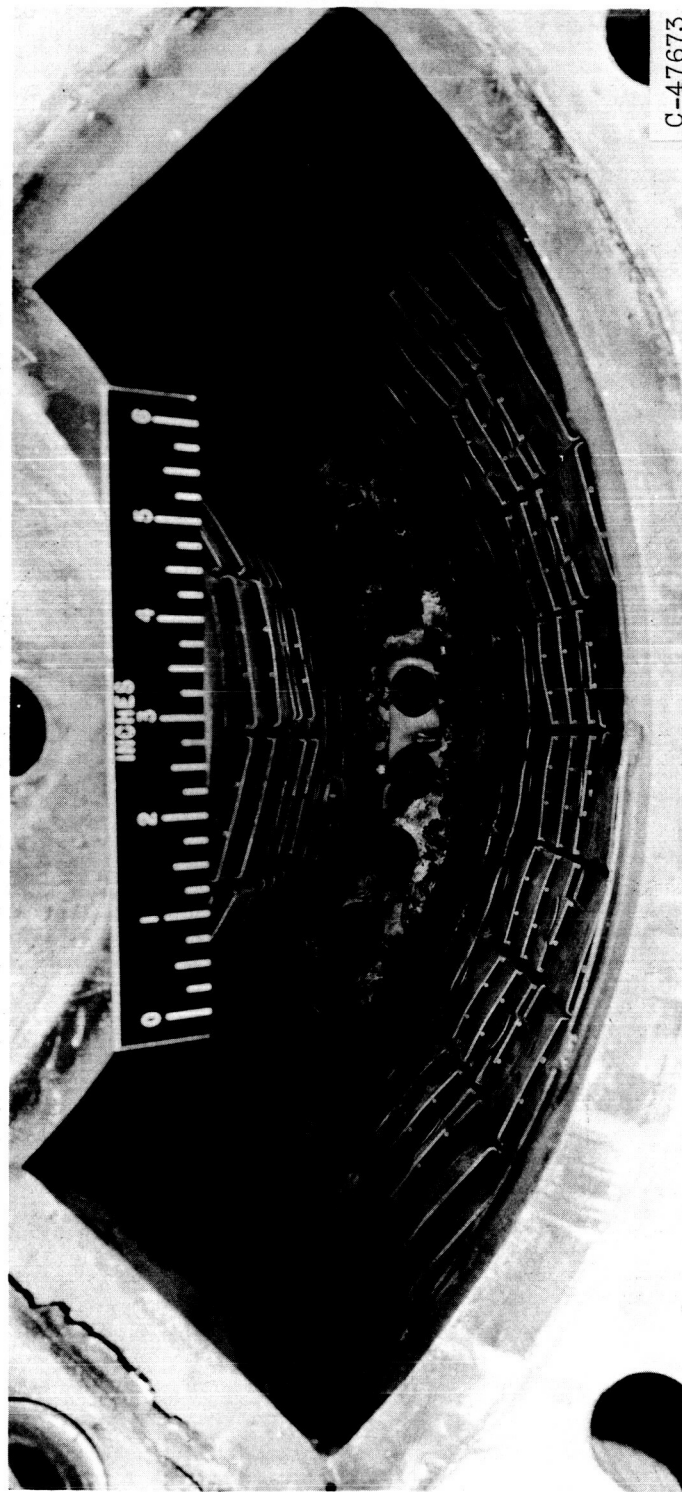
(c) Long-radius channels and pilot section after removal of coke deposits.

formation extended out past the pilot section. Except for a small amount of warping of some of the steps, the long-radius channels were in good condition. Figure 12(c) shows the pilot section with the coke removed. There was a considerable amount of warpage of some of the pilot-section steps. The coke deposits adhered to the pilot section much more securely than when the nozzle plate was installed.

Figure 12. - Concluded. Warped short-radius channels, coke deposits, and warped pilot-section steps. Run time, 41.2 hours.

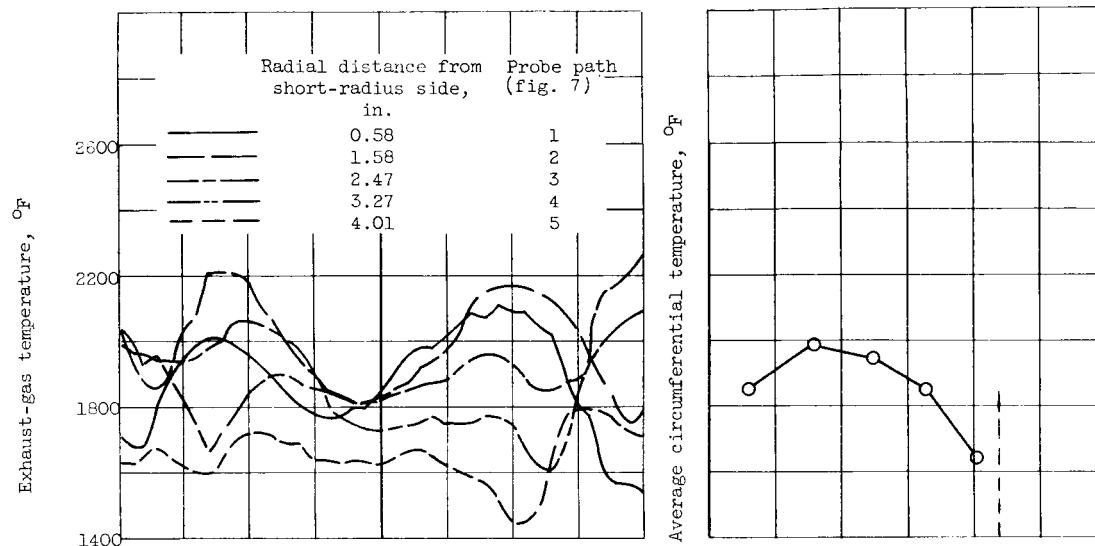
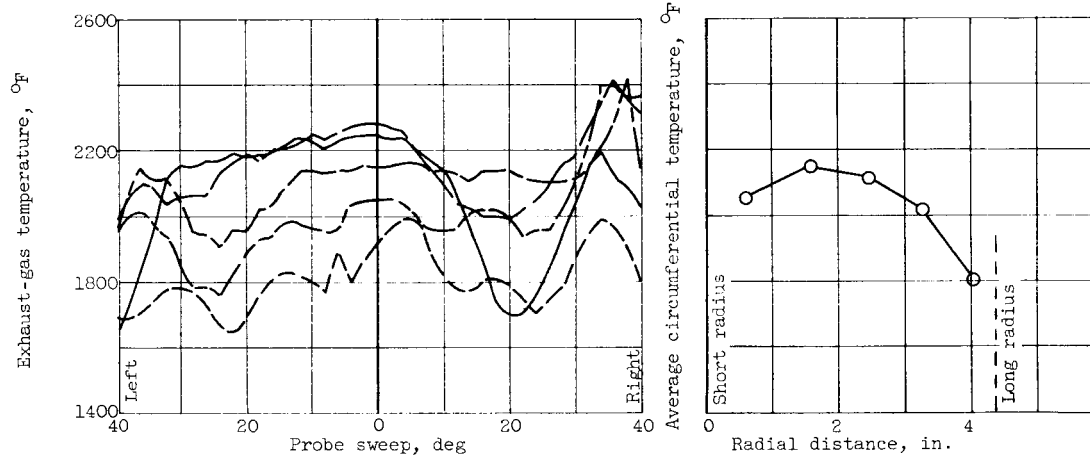
The combustor had been operated for about 7 hours (conditions A, B, and part of C) when the data of figure 13(a) were obtained. The average temperature for this run was 1857° F (desired 2000° F) with a maximum of 2260° F recorded. It appears that some warping had taken place, permitting an increase of dilution air near the center of the short-radius side. As described previously, it was during operation at this condition that two right-center short-radius channels had come loose (fig. 8). It is possible that some failure had already taken place when the data were taken.

Coke was cleaned from the combustor, and the damaged parts were replaced. The data of figure 13(b) was obtained after about 13 more hours of operation (conditions D, E, and part of F). An average exhaust-gas temperature of 2031° F was obtained (desired 2000° F) with a maximum recorded temperature of 2410° F. The sharp decrease in temperature of the number 1 profile at 20° right (probe sweep) indicates an increase in dilution air along this path rather than a blocked fuel nozzle. All profiles would be affected by nozzle blockage.

The plots of profile average temperatures show that those of profile 1 (short radius) are about 225° F higher than those of profile 5 (long radius). Peak variations were as much as 550° F. This may indicate why more warpage and all tab failures occurred on the short-radius side.

Figure 13. - Exhaust-gas temperature patterns obtained at two different operating conditions. View looking downstream.

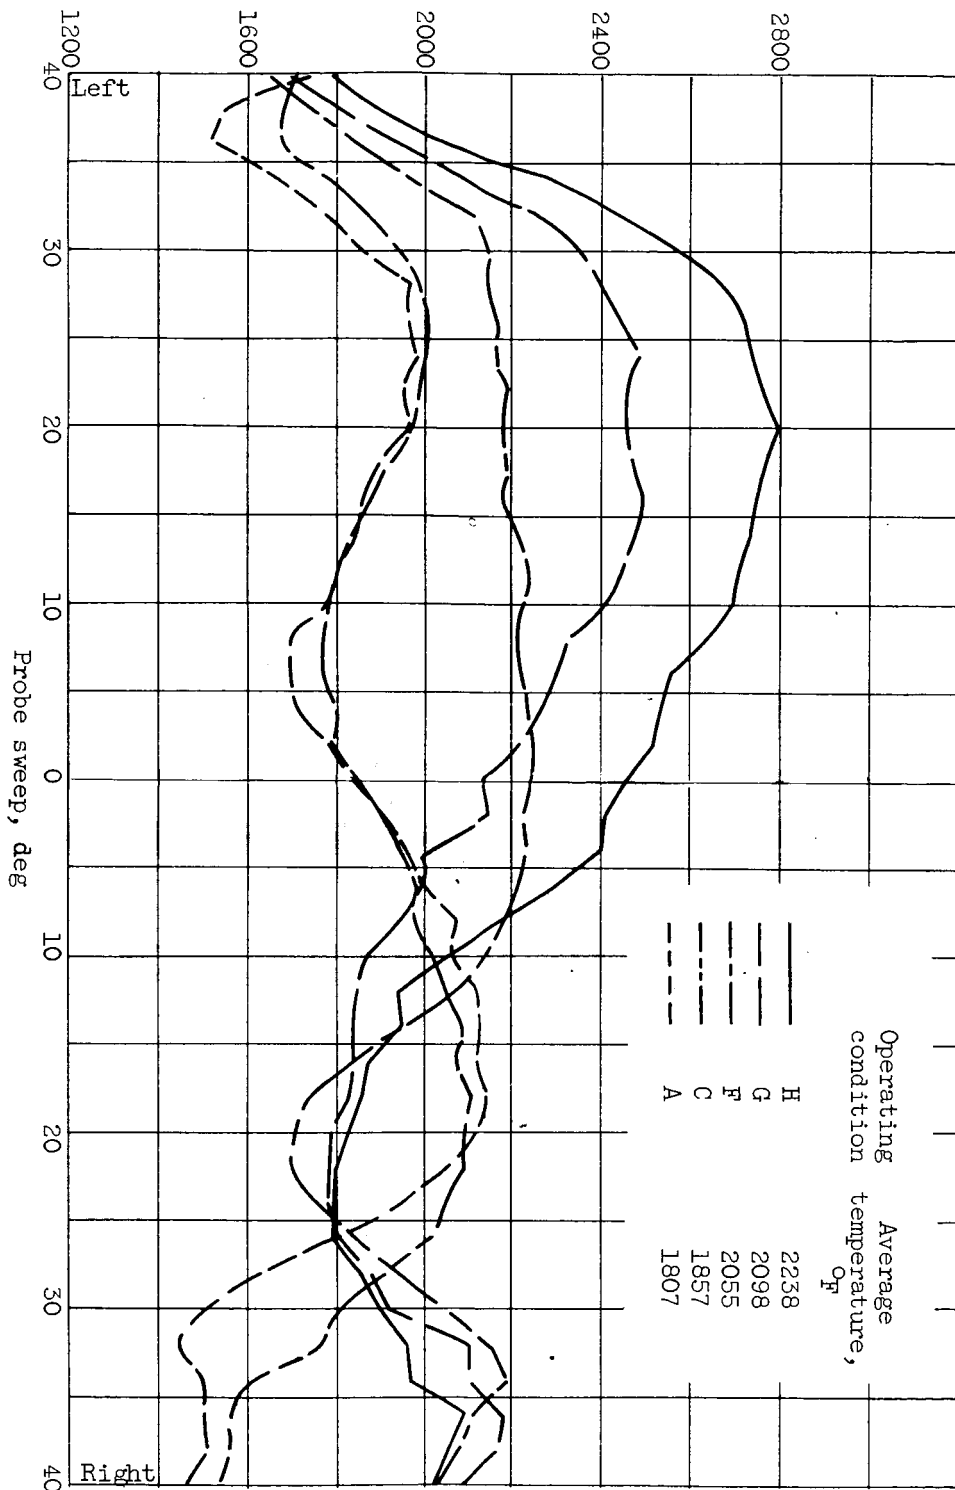
Figure 14 is a plot of profile-1 exhaust temperatures obtained at five different conditions. The data at conditions A and C were reasonably symmetrical. However, the profiles get progressively worse at conditions F, G, and H. For example, temperatures obtained at condition H varied from 2800° F at 20° probe-sweep left to 1800° F at 25° probe-sweep right.

Figure 14. - Exhaust-gas temperature patterns of probe path 1 (fig. 7) for several operating conditions. View looking downstream.
